NPIC/R-265/64 May 1964

PHOTOGRAPHIC INTERPRETATION REPORT

LAUNCH COMPLEX D TYURATAM MISSILE TEST CENTER, USSR CHANGES AND ADDITIONS

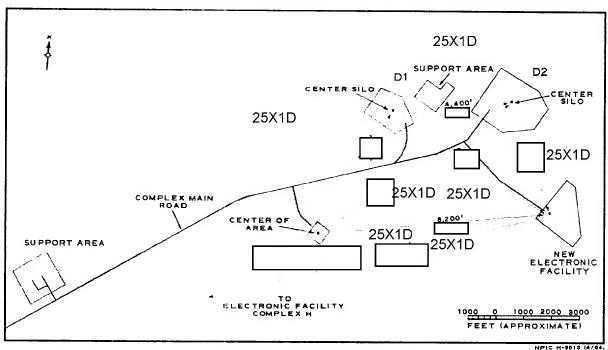
FIGURE 2. LAUNCH COMPLEX D.

The complex (Figure 2) was covered by missions in this interim. On photography the complex was partially cloud covered, and photographic

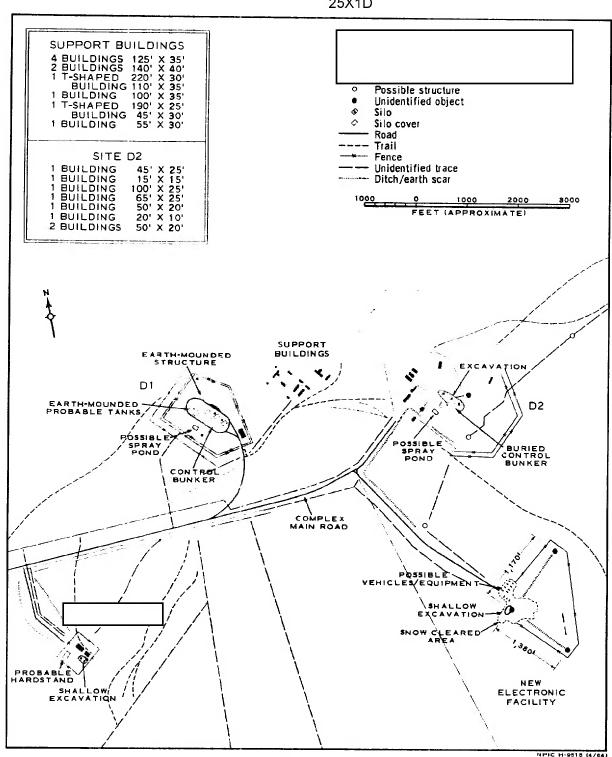
FIGURE 4. LAYOUT OF LAUNCH SITES DI AND D2.

age, which was unusable (Figure 4). Also	mensuration data can be given for the under-	
	included in the report are a line drawing of	ground elements of Site D1.	•
	the support area west of the launch sites		,
			•
	LAUNCH	SITE D1	
25X1D	Launch Site D1 (Figures 3 and 4) has	center silo covers. An earth-mounded struc-	
	remained virtually unchanged since	ture has been detected on the downrange side	
25X1D	On the coverage an unidentified	of the loop road near the northwest end. A re-	
	object was observed adjacent to the right and	view of earlier photography shows that this

covers are not in place. The control bunker is covered over with earth, and its location is vague. It appears to be lower or deeper than its counterpart at D1, where the top of the control bunker is slightly higher than site ground level. An unidentified object, located 225 feet forward of the right silo, is connected by an unidentified trace with the center silo. An unidentified trace in the snow extends from a possible structure on the southeast side of the site northeastward to two possible structures located approximately 3,000 and 9,500 feet away. The possible spray pond cannot be identified.

Ditching extends from the vicinity of the control bunker to a point near one of the buildings at the west end of the site. A branch from this ditch appears to go under a small building and then continues to the complex main road where it turns southwest and parallels

the road until it reaches a new access road leading to a new electronic facility. The ditch parallels the new road for approximately half of its length. Unidentified traces in the snow appear to connect the electronic facility to D2. There are no apparent connections to D1, although unidentified traces along the main access road, which are probably utilities, appear to serve all major segments of Launch Complex D.

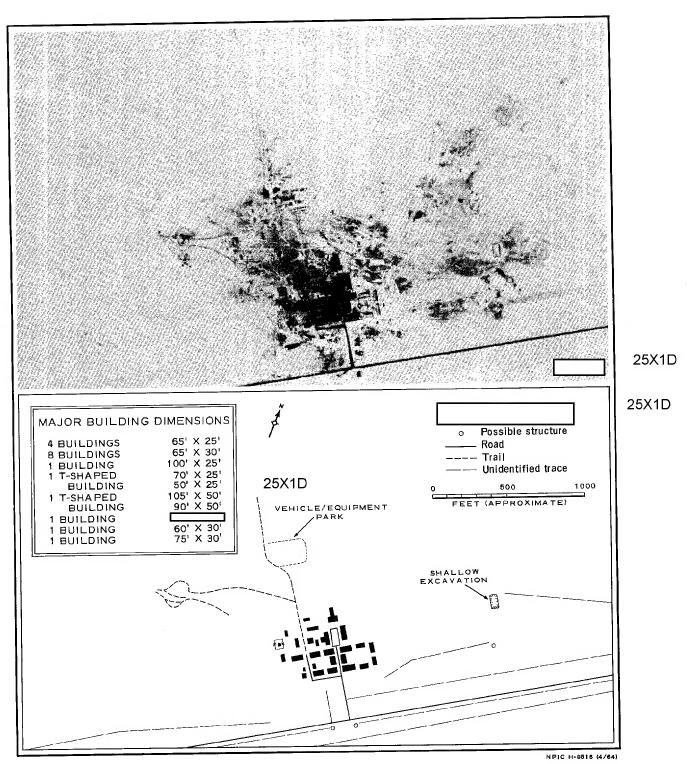
FIGURE 5. SUPPORT AREA WEST OF LAUNCH SITE D1.

There are two support areas (Figures 4 and 5) in the vicinity of Launch Complex D. One is located approximately halfway between the two launch sites and the other is 2.3 nautical miles (nm) west of Dl on the north side of the complex main road. Each of these sup-

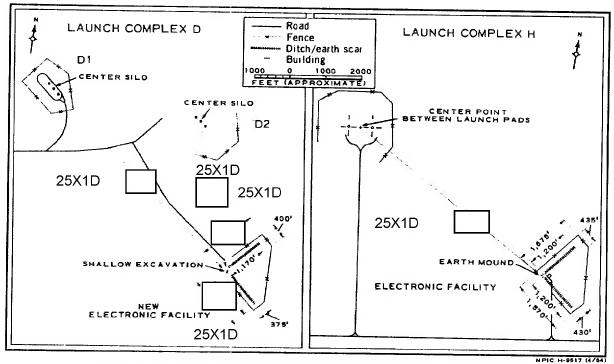
FIGURE 6. COMPARISON OF ELECTRONIC FACILITIES AT LAUNCH COMPLEXES D AND H.

The electronic facility is located 4,100 feet south of D2 and consists of a triangular-shaped secured area containing two earth scars or ditches, 1,170 and 1,380 feet in length. They form a right angle, and an unidentified object and a shallow excavation are located at the intersection of the legs. An unidentified object is also located at the extremity of each leg. A group of unidentified objects near the entrance to the secured area may be vehi-
